Guidelines for
**Preservation, Stewardship
& Development**

Guidelines for the
Preservation, Stewardship, and Development
of the
Dimock Community Health Center Campus
55 Dimock Street
Roxbury, Massachusetts

Prepared by August Associates, Architects
under contract with
Historic Boston Incorporated
with partial financial support through the
Boston Landmarks Commission
from the City of Boston
Neighborhood Development and Employment Agency
Community Development Block Grant funds.

November 1984

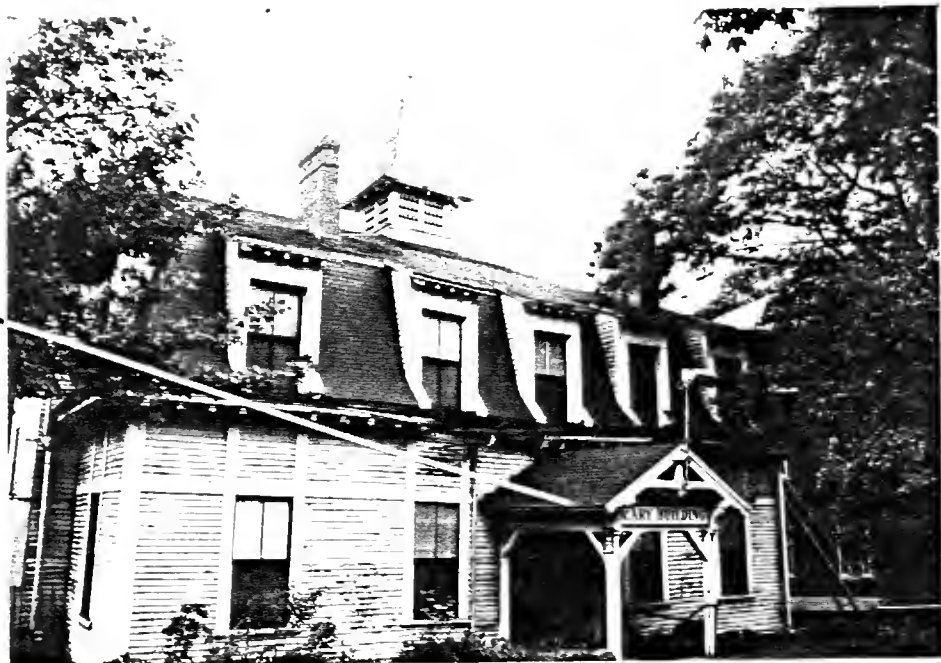
1

Tudor stick style
Porte-Cochere

<u>Area of Work Arranged in Order of Priority; & Photo Key</u>	<u>Estimated Cost</u>	<u>Maintenance & Scheduling</u>
1. Reroof main roof, cupola, dormers and porte-cochere. (Photos # 1, 2, 3, 5, 6, 9)		New roof lasts 15-20 yrs

3. All exterior wood surfaces need to be repaired, scraped and sanded, restored, or replaced. (Photos # 1, 2, 3, 4, 5, 6, 7, 8, 9, 10)		Paint every 4-6 yrs

5. Reduce air infiltration in window areas by weather strip- ping, reglazing, caulking seams and repairing sills. (Photos # 1, 2, 4, 5, 7, 10)		Paint every 4-6 yrs Reglaze every every 4-6 yrs

6. Remove exterior flood light from porte-cochere gable end. (Photos # 1, 2)		N/A
7. Replace front hand rail with more compatible style. (Photos # 2, 4)		Paint every 4-6 yrs

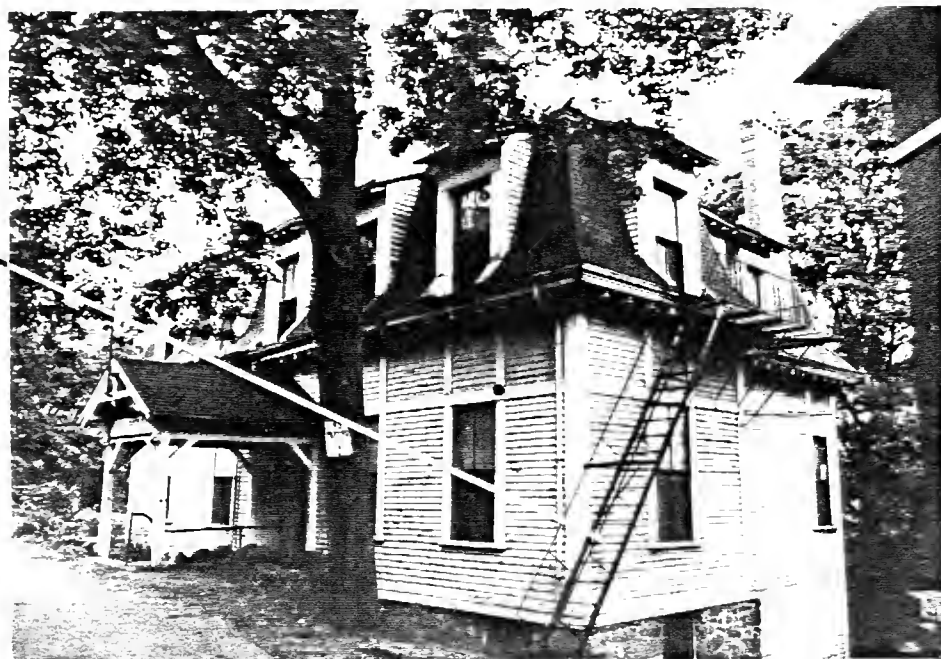
2

Fire escape

4. Remove all loose, mismatched unsound mortar and masonry from chimneys and foundations. Repoint, repair and replace as necessary to retain original character. (Photos # 2, 8, 9, 10)		Check and and repair every 10-15 yrs

<u>Area of Work Arranged in Order of Priority; & Photo Key</u>	<u>Estimated Cost</u>	<u>Maintenance & Scheduling</u>
9. The fire escape at the northeast corner, assuming it should remain to meet code requirements, should be re-designed and/or repainted to reduce contrast and blend with building. (Photos # 1, 2, 10)		Regular maintenance for proper working condition. Scrape and paint every 4-6 yrs
10. Manhole on front porch should be lowered and made less prominent.		N/A

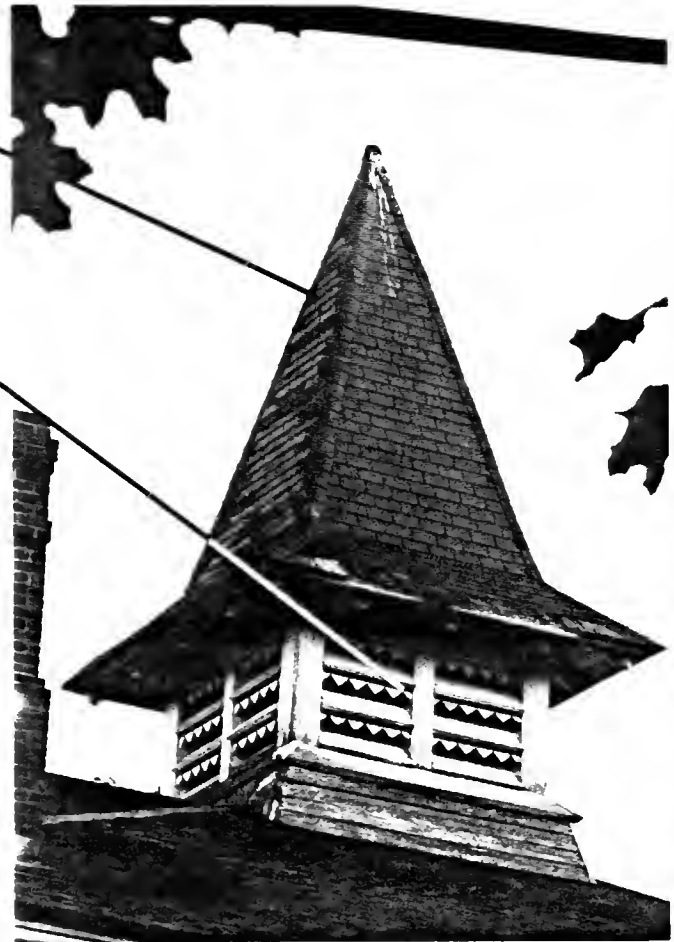
3

Pyramid shaped roof cupola

Sawtooth louvers

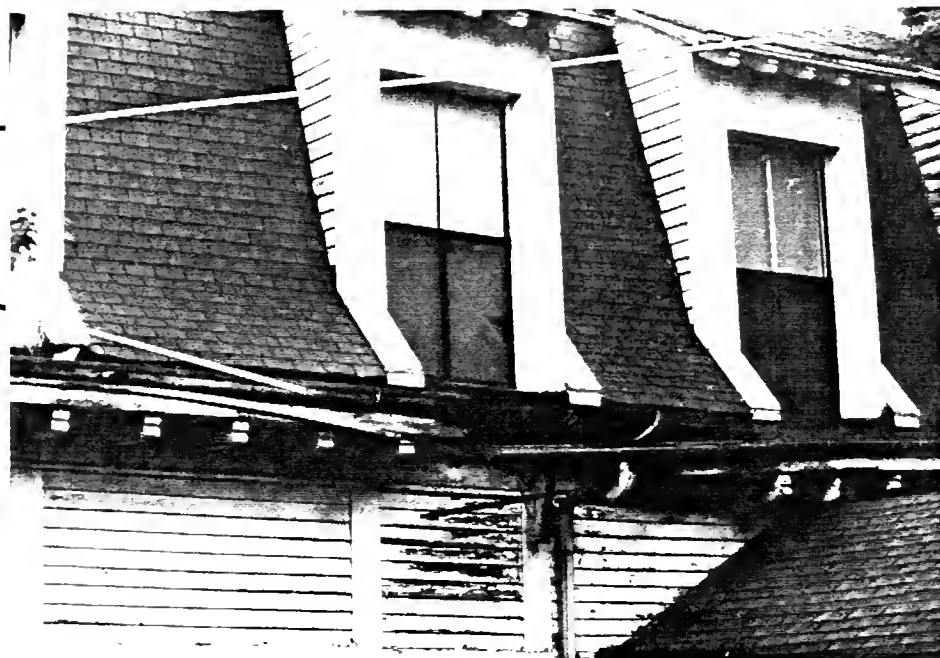
5

Shed dormer

Wooden gutter

2. Restore wooden gutters, sup- porting brackets, fascia, sof- fit area and downspouts. (Photos # 1, 5, 6, 7, 9, 10)		Repaint every 4-6 yrs. Clean gutters every spring and fall

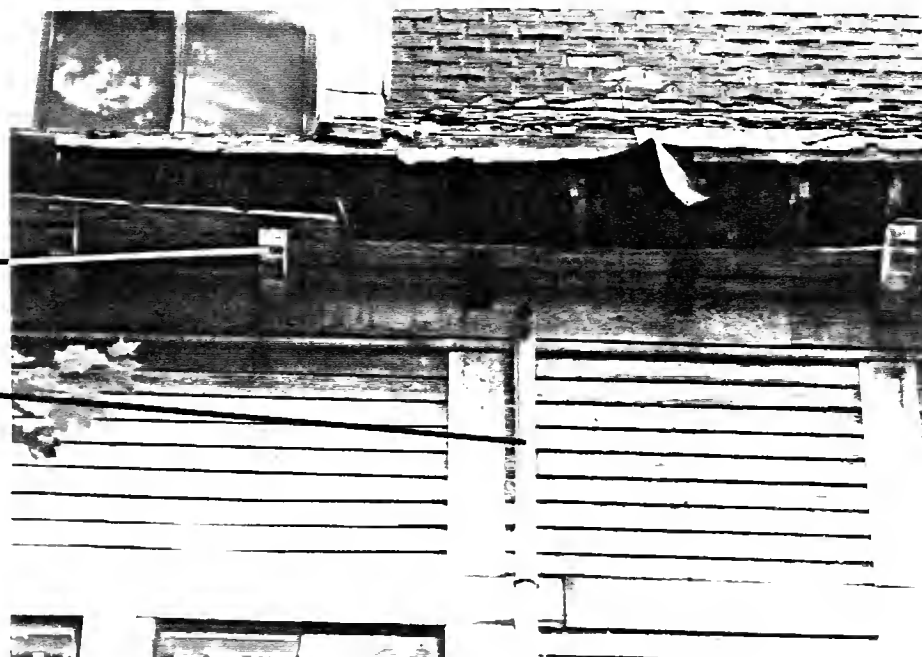
6

Brackets

Downspout

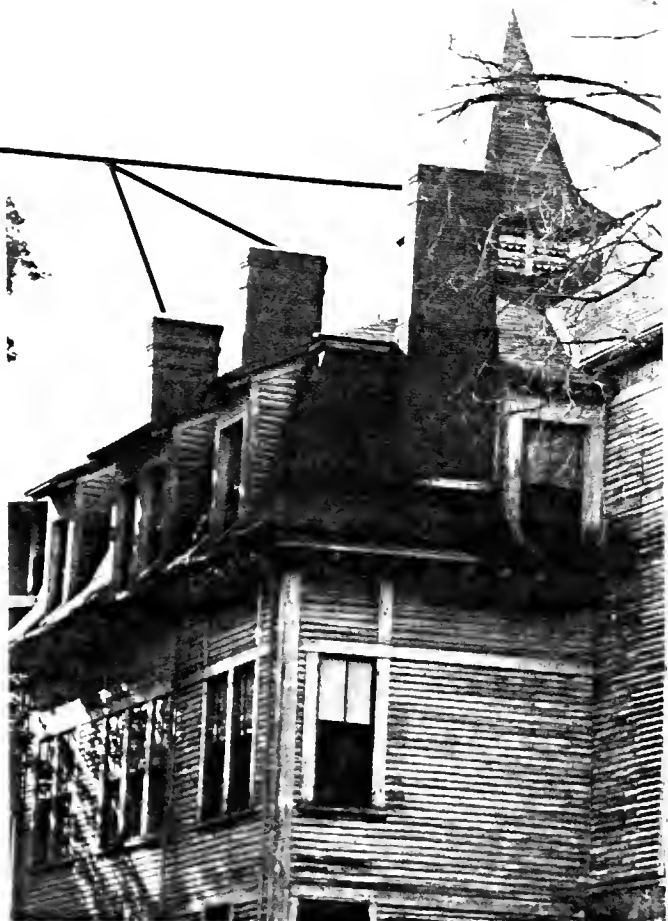
7

Brick detailed chimneys

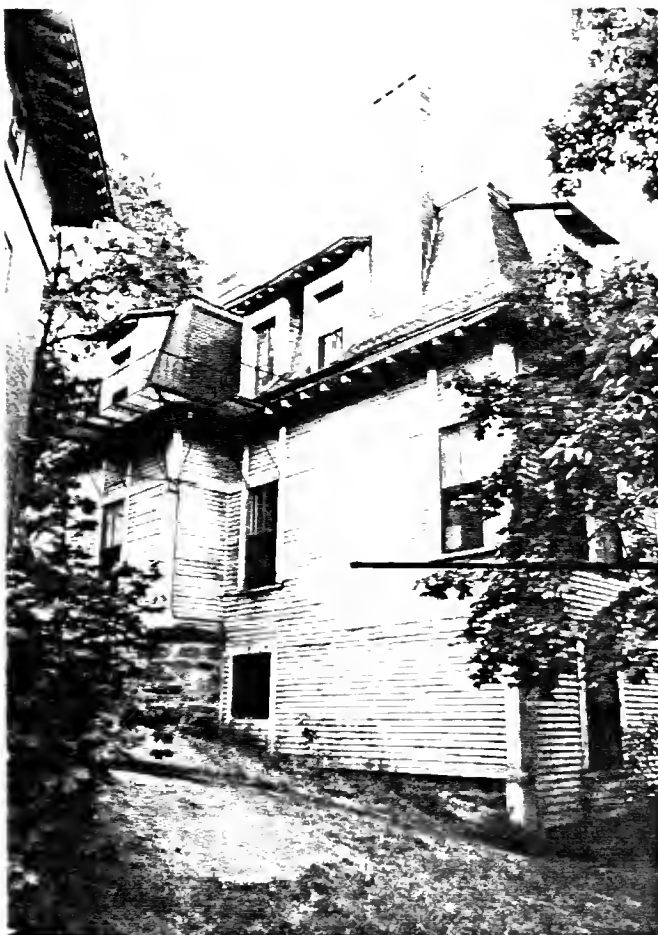
10

Clapboard siding

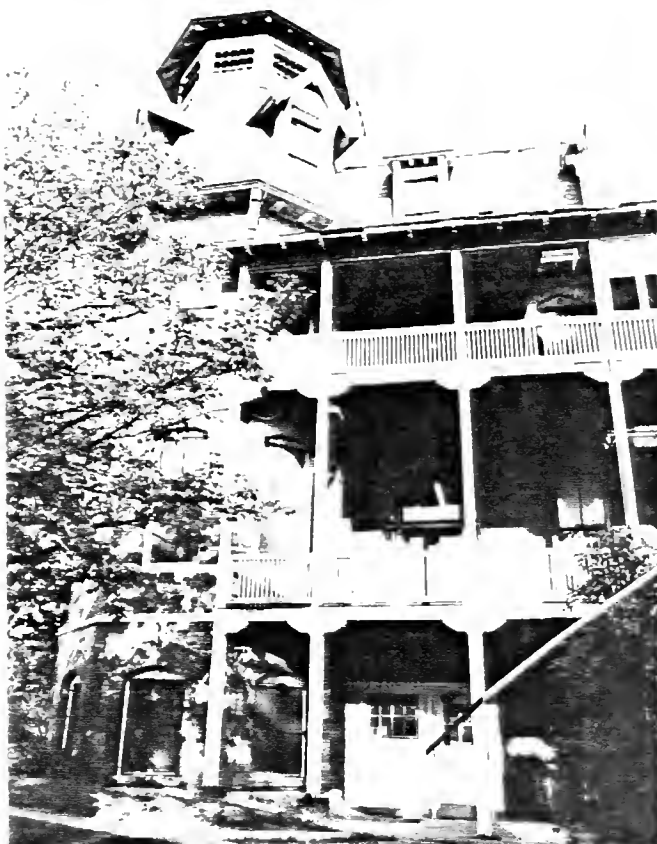
22

Shed storage, to be removed

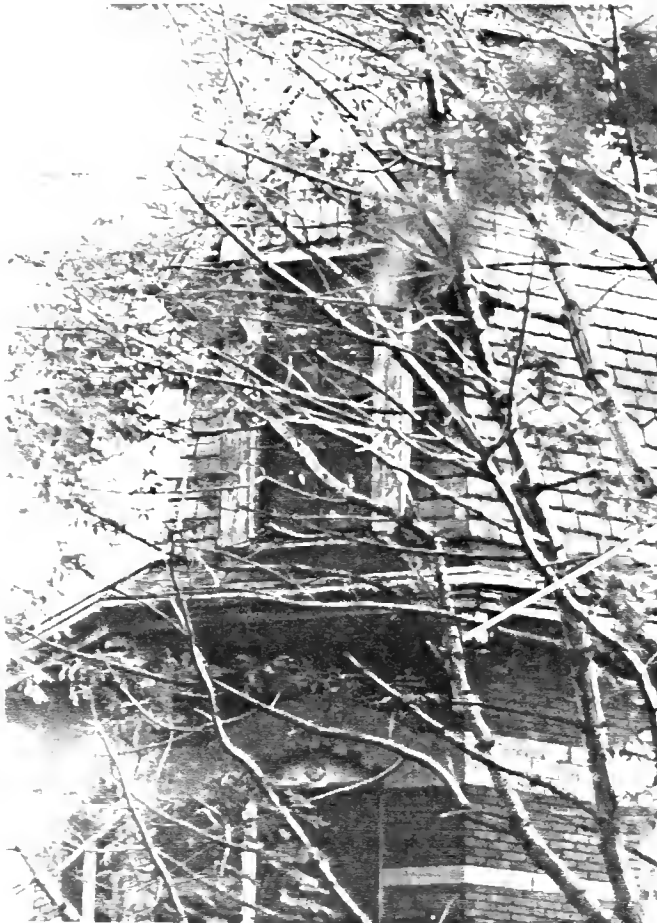
30

Wooden gutter and bracket in need of restoration

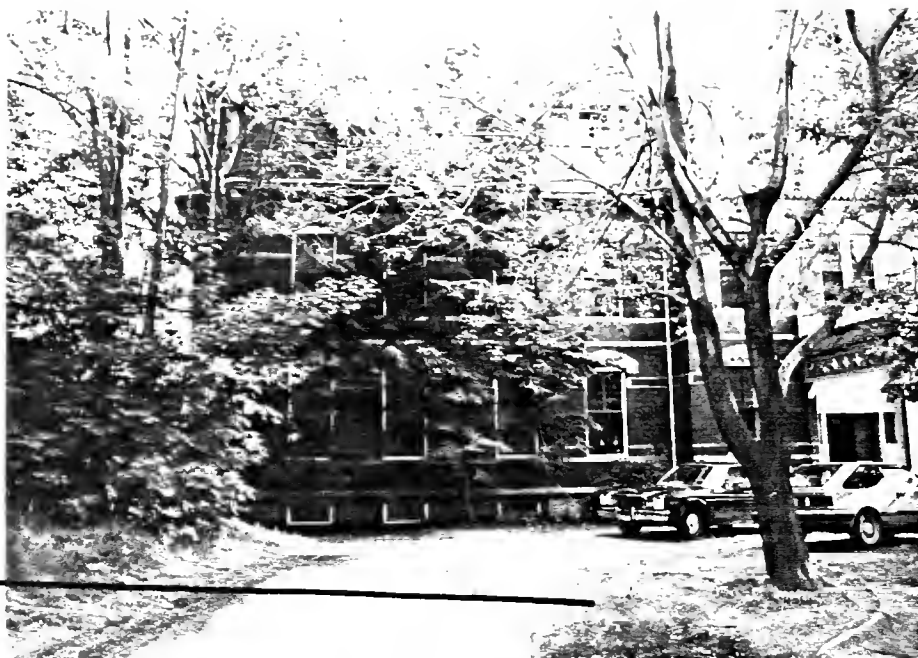
31

grass planting and curbs
needed

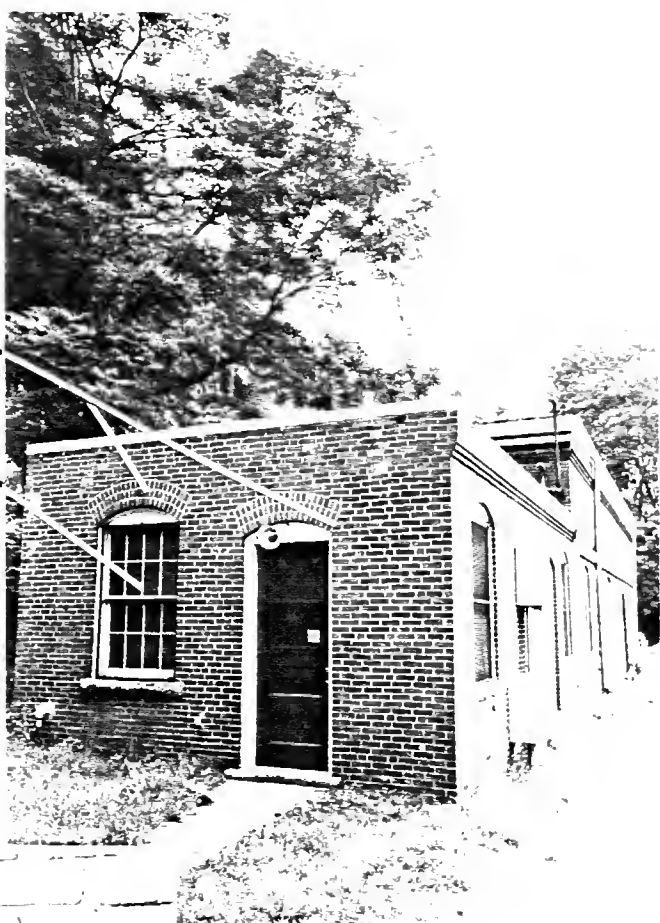
32

Segmentally arched windows and doorways

8/8 double hung wooden sash windows

<u>Area of Work Arranged in Order of Priority; & Photo Key</u>	<u>Estimated Cost</u>	<u>Maintenance & Scheduling</u>
1. Repair & renovate roof and its drainage system, including the roof, wooden & metal gutters, downspouts & drains. (Photo # 34)		B.U.R. good for 20-30 yrs, Paint gutter system 4-6 yrs. Remove leaves & sticks spring & fall
2. Remove all loose, unsound & mismatched mortar & masonry. Repoint, repair & replace as necessary to retain original character. (Photo # 34)		Check & repair 10-15 yrs
3. Renovate windows, making as air tight as possible using weather stripping, reglazing, new glass, etc. Repair weight & pulley system for raising & lowering sashes. Remove unnecessary and unsightly bars & screens. (Photo # 32)		Paint 4-6 yrs Glaze 4-6 yrs Repair as required

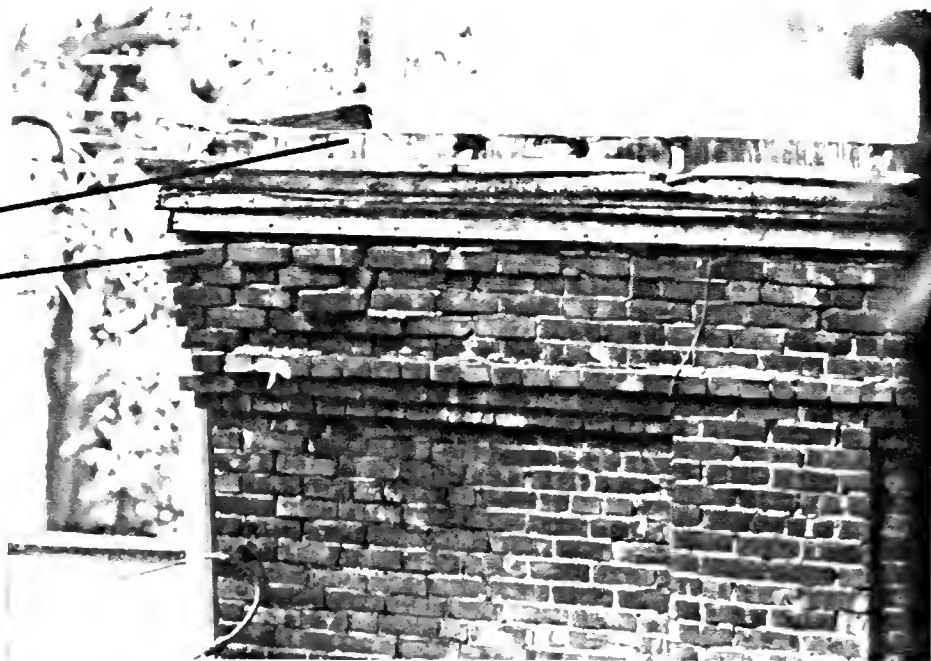
34

Repair roof water drainage
system

Brick cornice

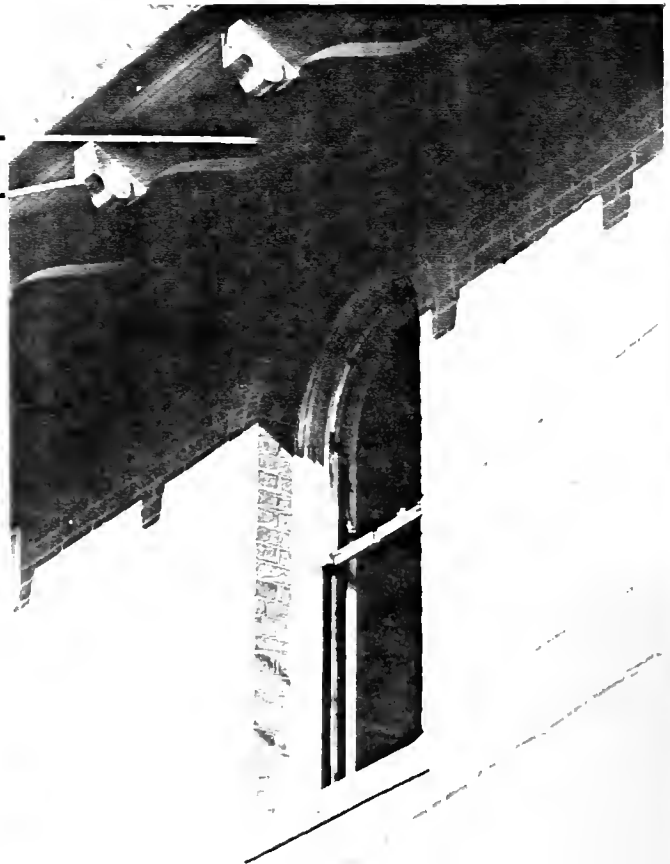
37

Exposed soffit

Ornately sawn rafter-tail

<u>Area of Work Arranged in Order of Priority; & Photo Key</u>	<u>Estimated Cost</u>	<u>Maintenance & Scheduling</u>
1. Renovate roof & roof water drainage system. Severe deterioration present. Keep historic character. (Photos # 36, 37)		New asphalt roof good for 15-20 yrs. Gutters painted 4-6 yrs, cleaned spring & fall

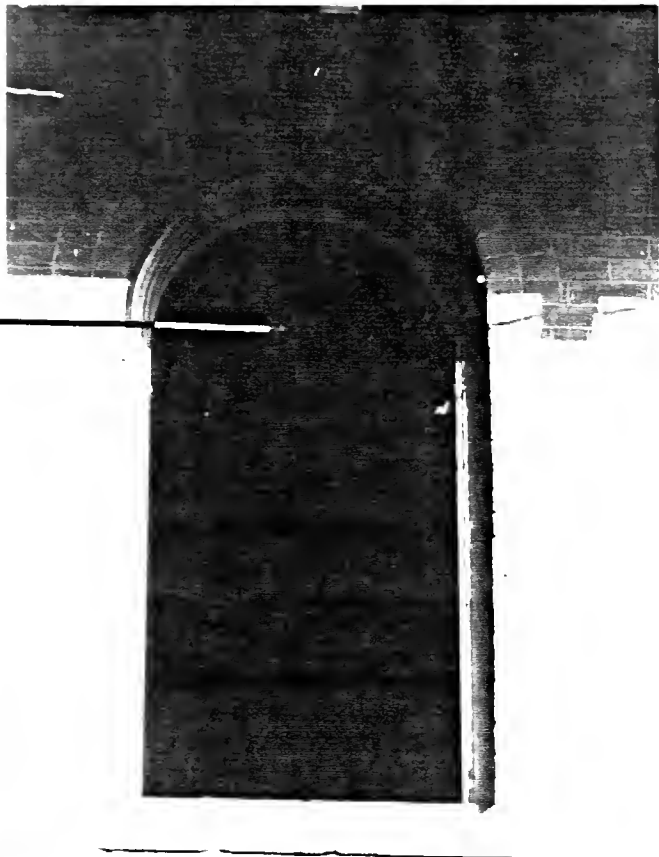
40

Round arch window

2. Replace all windows with thermal pane, thermal break metal frame units, matching original as closely as possible. This is necessary because most of the existing windows have been damaged beyond repair. (Photos # 38, 39, 40)		Virtually no maintenance on new windows

3. Remove all loose, mismatched & unsound mortar & masonry. Repoint, repair & replace as necessary to retain original character. (Photos # 38, 39, 40, 41)		Inspect & repair, 10-15 yrs

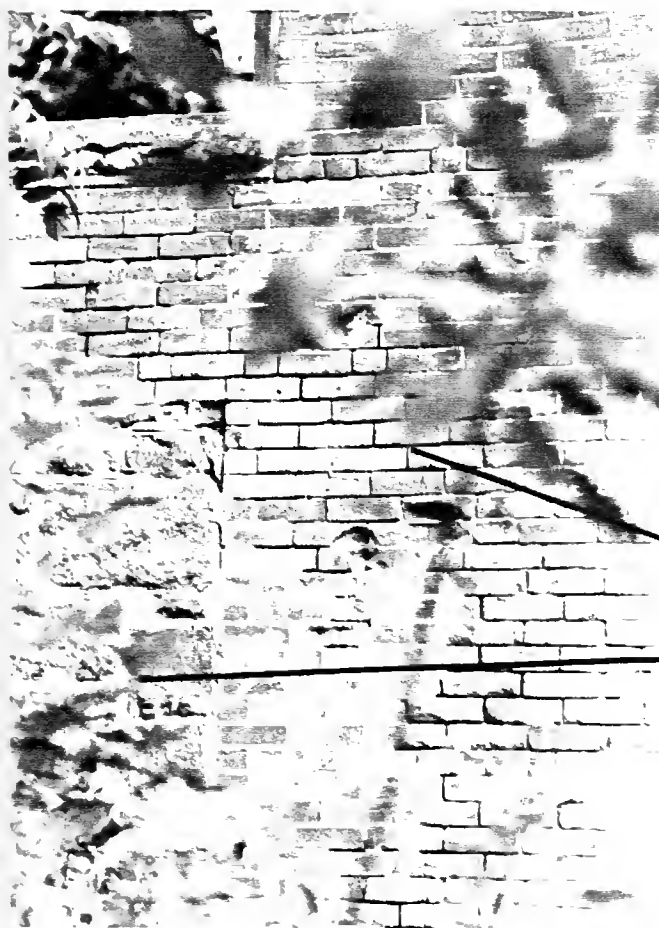
Repoint mortar

Exposed native stone foundation

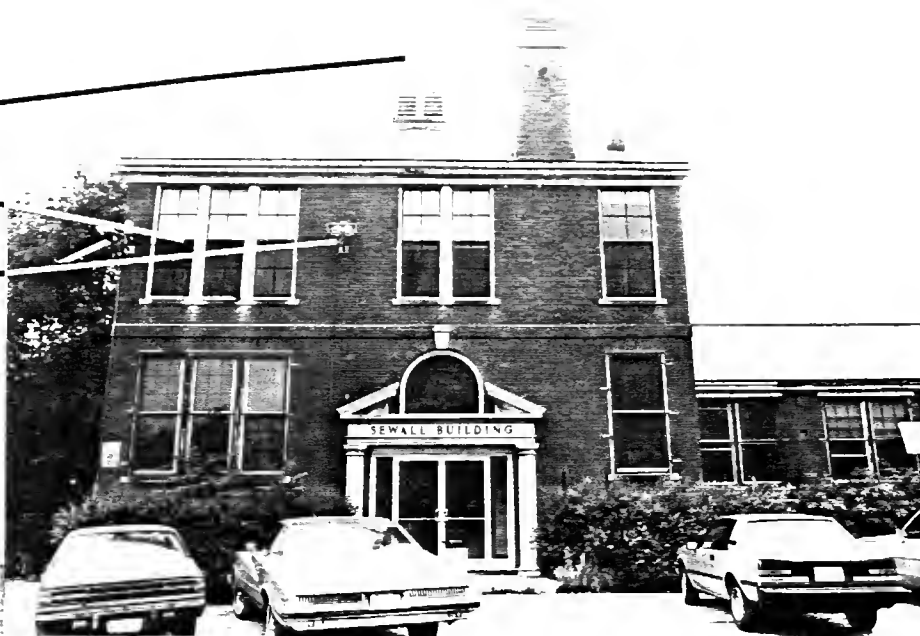
42

4/4 wood sash window

Modern flood lights

2. Restore windows to original conditions. Remove boarded up lights, relocate exhaust vents, take down unnecessary security screens. Renovate windows to an airtight condition using weather stripping, reglazing, sill repair, caulking, new glass, etc. Repair sash weight & pulley system. (Photos # 42, 43, 44, 45, 46, 47, 50, 51, 52, 55)		Paint & reglaze every 4-6 yrs

3. Inspect all exterior brick walls & chimney surfaces. Remove all loose, mismatched & unsound mortar and masonry. Repoint, repair & replace as needed. (Photos # 42, 43, 45, 46, 47, 49, 50, 53, 55)		Check & repair every 10-15 yrs

4. Replace aluminum & glass front entrance with an entry based on photographic evidence of the original doors. (Photos # 42, 43)		Repaint every 4-6 yrs

5. Repair, restore, replace, scrape, sand & paint all exterior wood surfaces. (Photos # 42, 43, 44, 45, 46, 47, 48, 50, 52, 53)		Repaint every 4-6 yrs

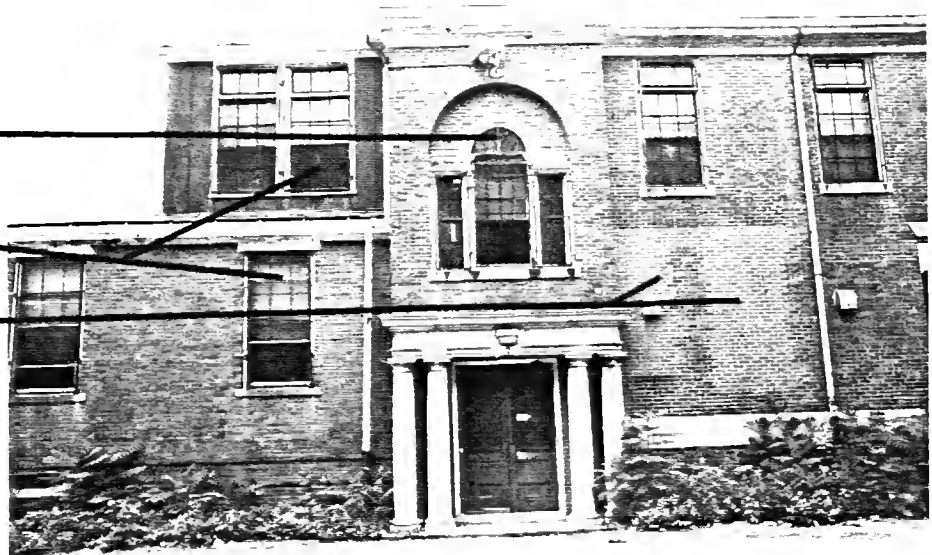
47

Palladian window

Security screens

Bricked-in windows

<u>Area of Work Arranged in Order of Priority; & Photo Key</u>	<u>Estimated Cost</u>	<u>Maintenance & Scheduling</u>
6. Scrape rust and scale from iron railings & repaint with rust inhibiting paint. (Photos # 48, 49, 52, 53, 54, 55)		Check, repair and paint every 4-6 yrs
7. Concrete arcade & its slab roof deck spalling. Repair to maintain structural integrity. (Photo # 52)		Inspect regularly & repair as needed
8. Remove modern floodlights attached to brick walls. (Photos # 42, 43, 47, 50)		N/A
9. Relocate exhaust ducts and vents in bricked up windows on east side. Restore windows to their original locations. (Photo # 47)		Repaint & re-glaze every 4-6 yrs

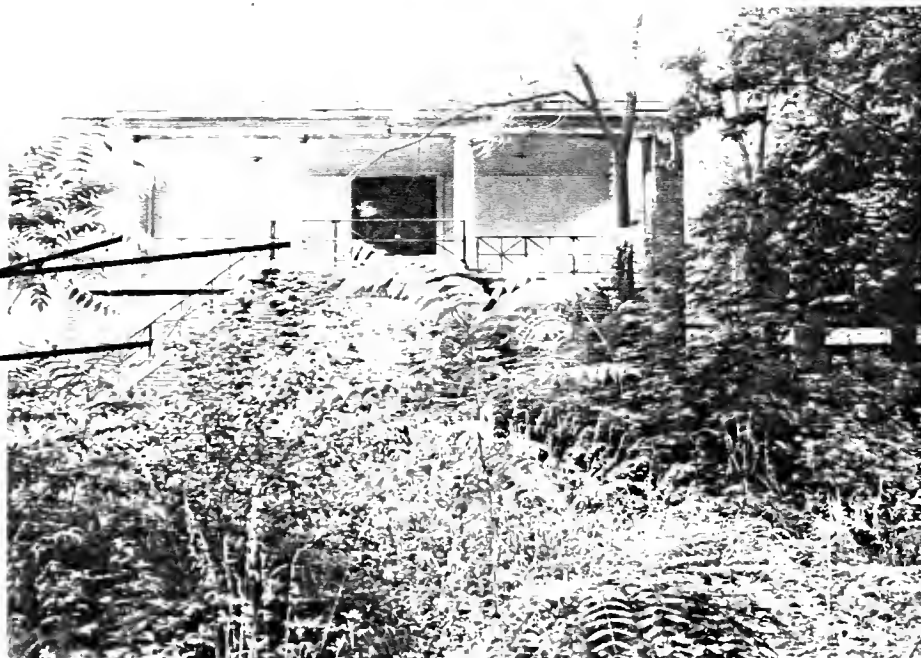
48

Tuscar. columns

Iron railing

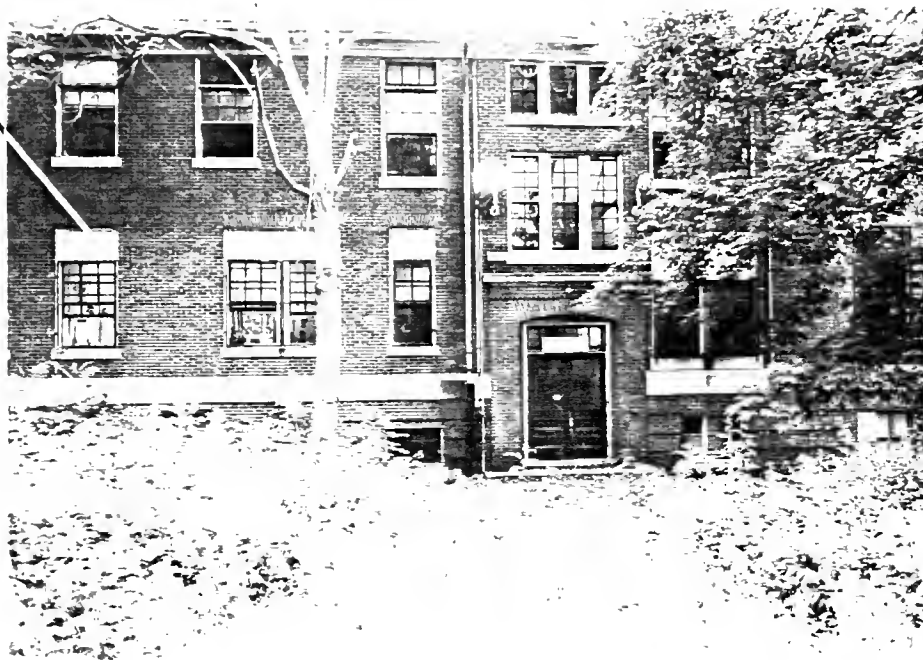
50

boarded in transom windows

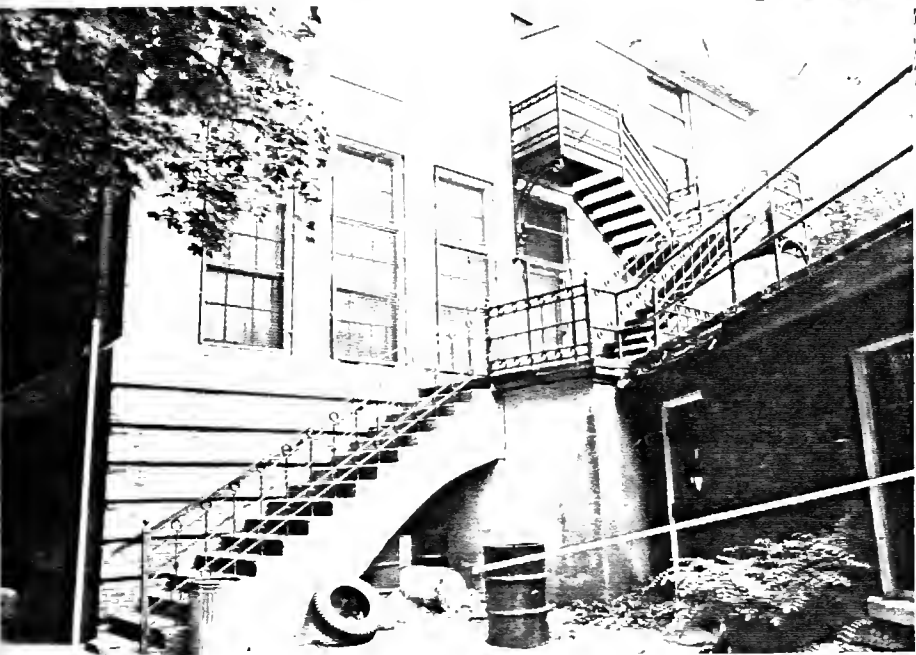
55

Clean up area

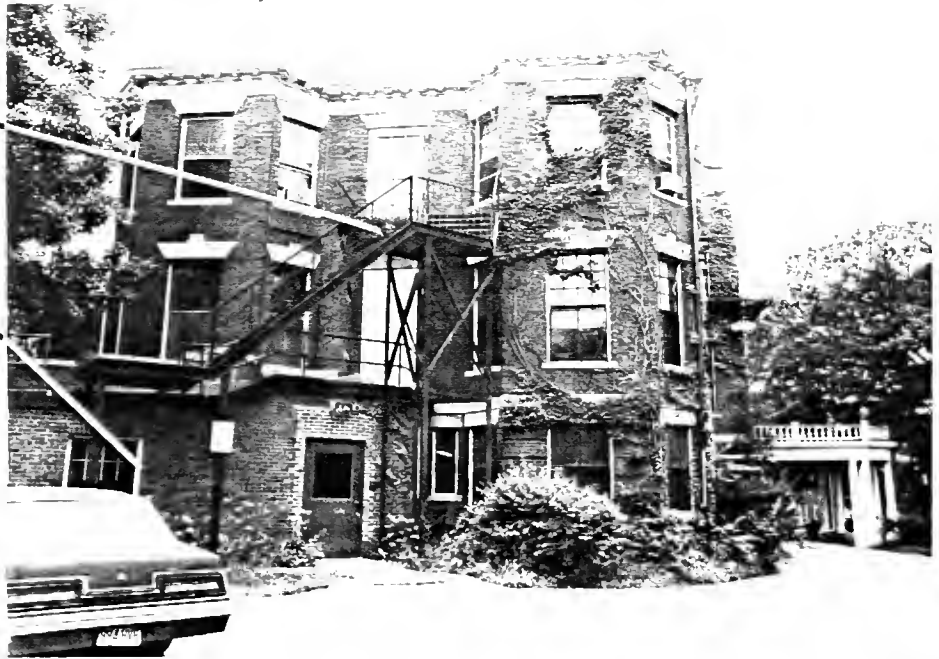
62

Fire escape on north side

Service tunnel to Richards Building

10. Restore balustrade to lower wings of buildings. (Photos # 62, 63, 64, 67)		Paint 4-6 yrs
11. Restore porte-cochere. See historic photos for original conditions. (Photos # 56, 57, 58, 61, 62, 66)		Check & clear roof of leaves spring & fall. Paint wood 4-6 yrs

12. Aluminum storm windows & screens should be replaced with less conspicuous protective enclosures. (Photos # 62, 63)		Depends on system - wood needs paint every 4-6 yrs, aluminum virtually maintenance free

13. Scale down fire escape on north side. (Photo # 62)		See #7

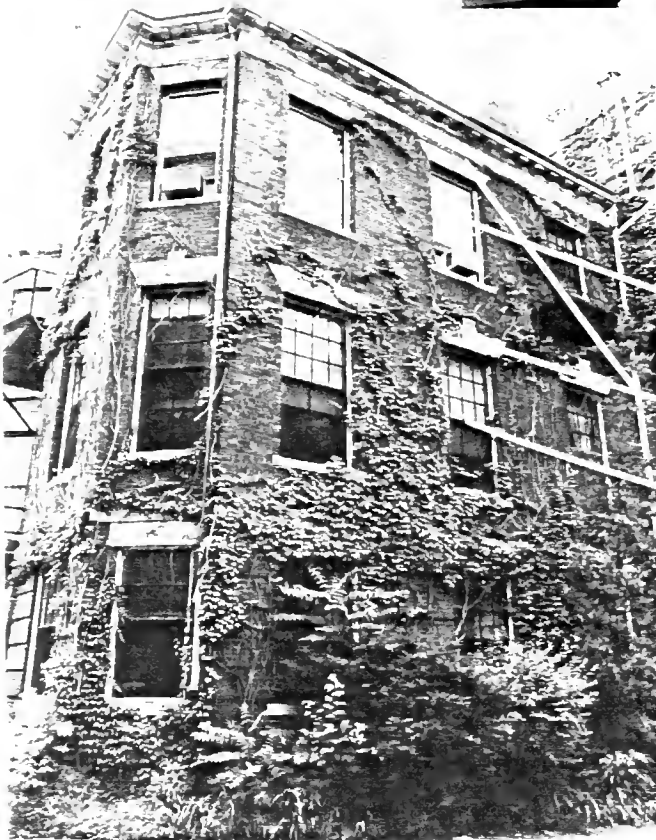
Aluminum storm windows

Flared stone lintels

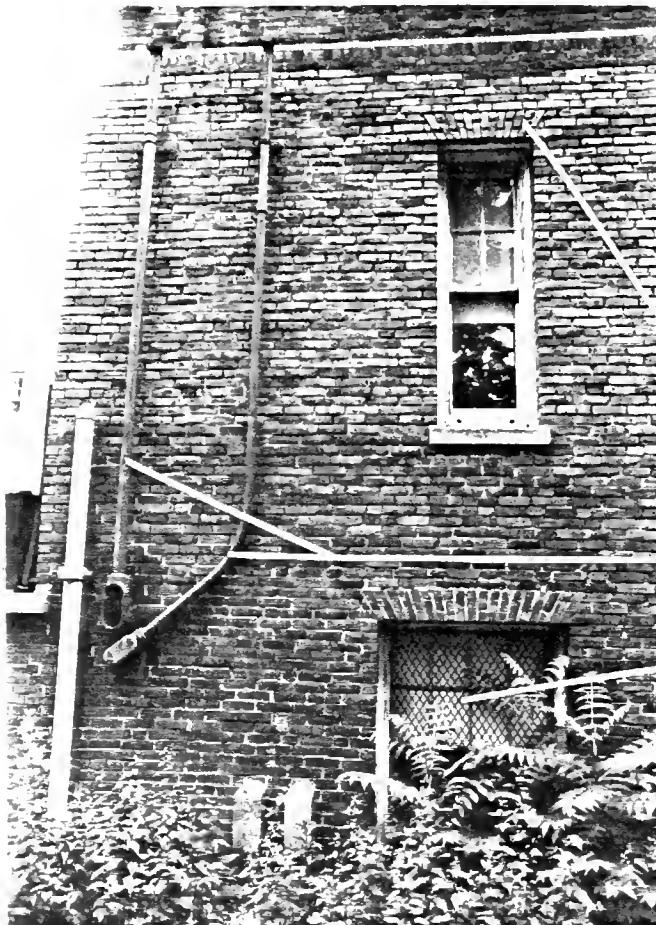
Unnecessary utilities connections

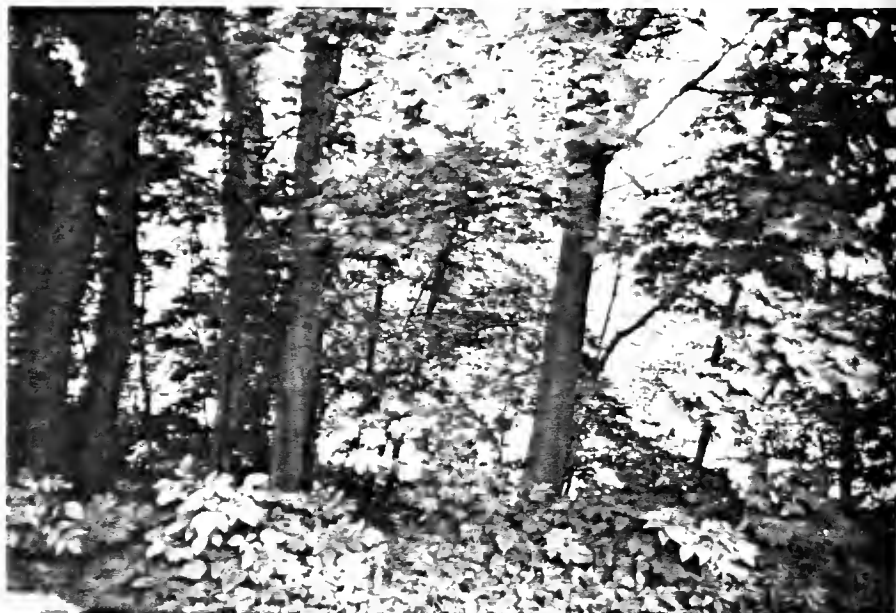
89

Nice deciduous planting, adequate summer screening of views into the site as well as from the parking area. Needs evergreen planting for year-round coverage. (Rhododendron, Ilex, Hemlock, Taxus, etc.)

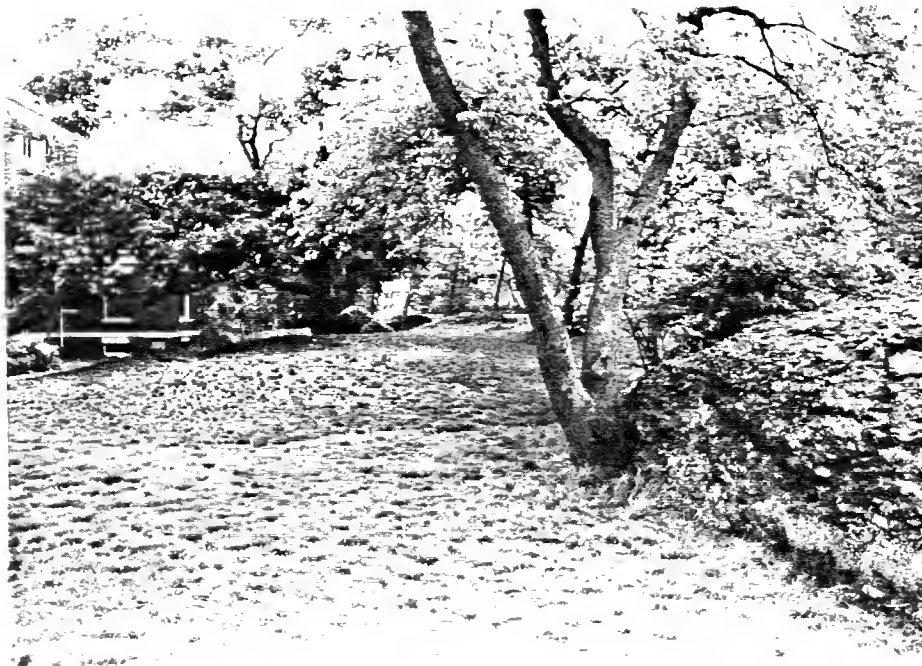
91

Replace grass with
groundcover massings
(vinca minor, pachy-
sandra) for better
coverage and reduced
maintenance.

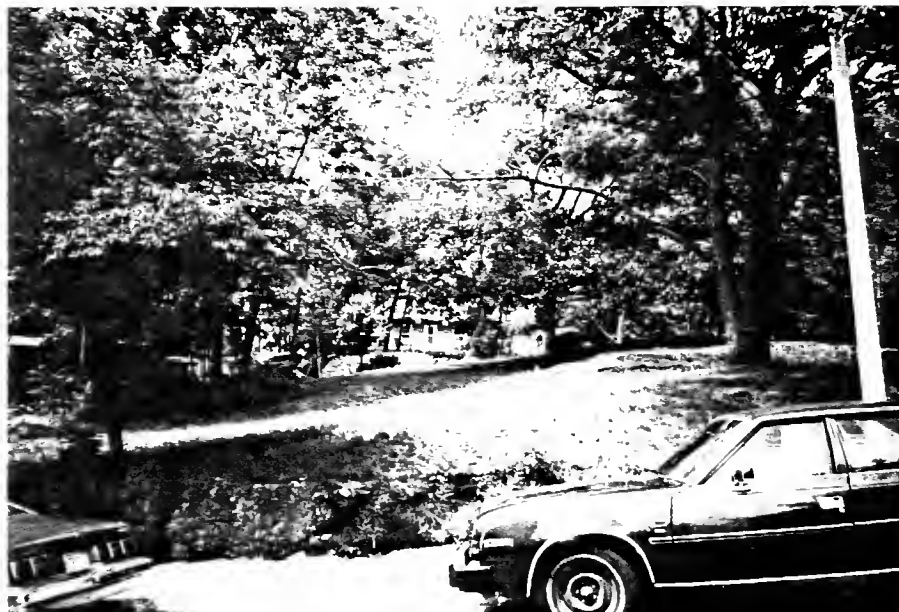
96

This view through the outcrop area could be just as nice as the view (11) across the road given the proper maintenance, i.e. trimmed edges.

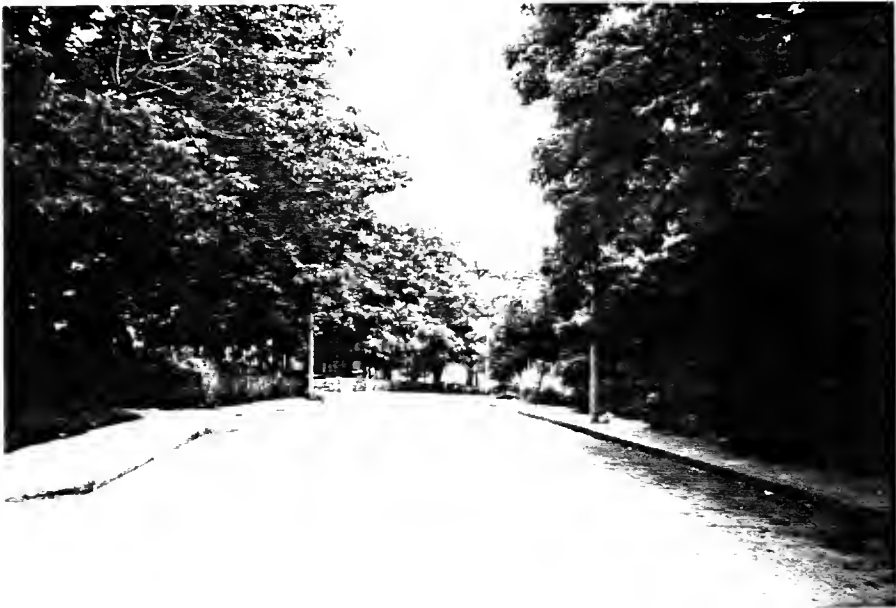
102

The Washington Street entrance needs definition.

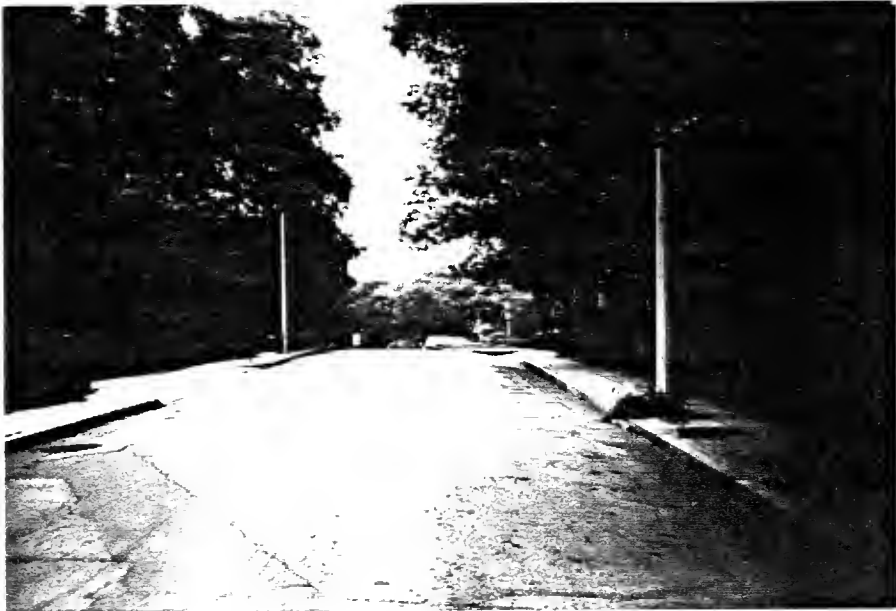
103

There is no indication of arrival or directional information at the Washington Street entrance

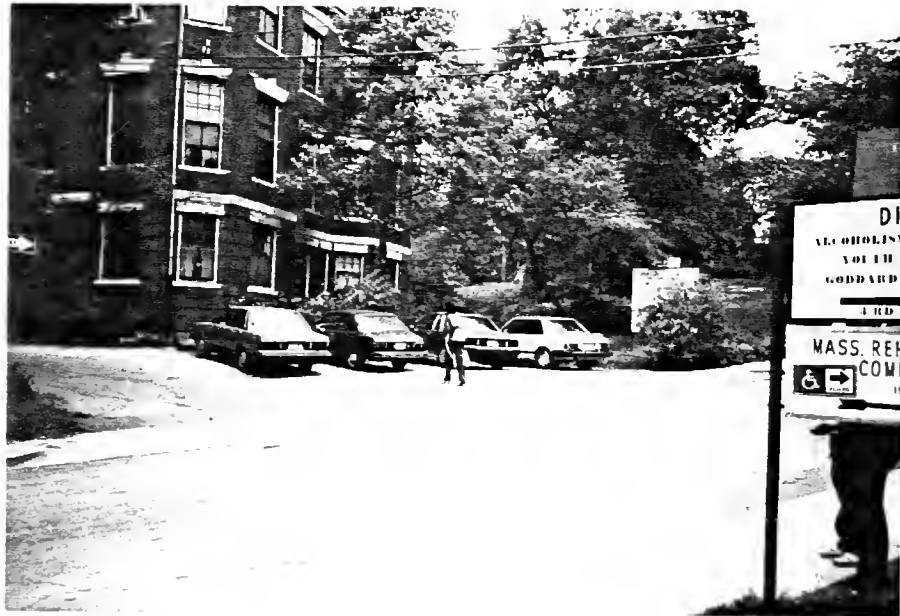
105

The edges of Dimock Street, the campus spine, should be better defined. This can be done through street trees, reduced curb cuts, and restricted parking. The parking shown here should be eliminated.

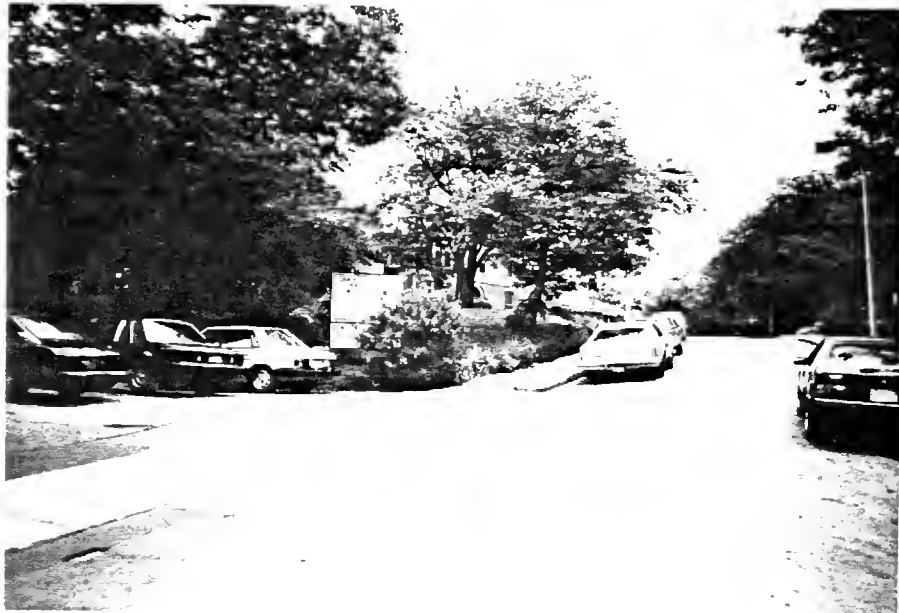
106

Curb cuts along Dimock Street are too broad. Signs too temporary. Site lines obscured by plants. Parking on Dimock Street, if any, should be on one side of the street only.

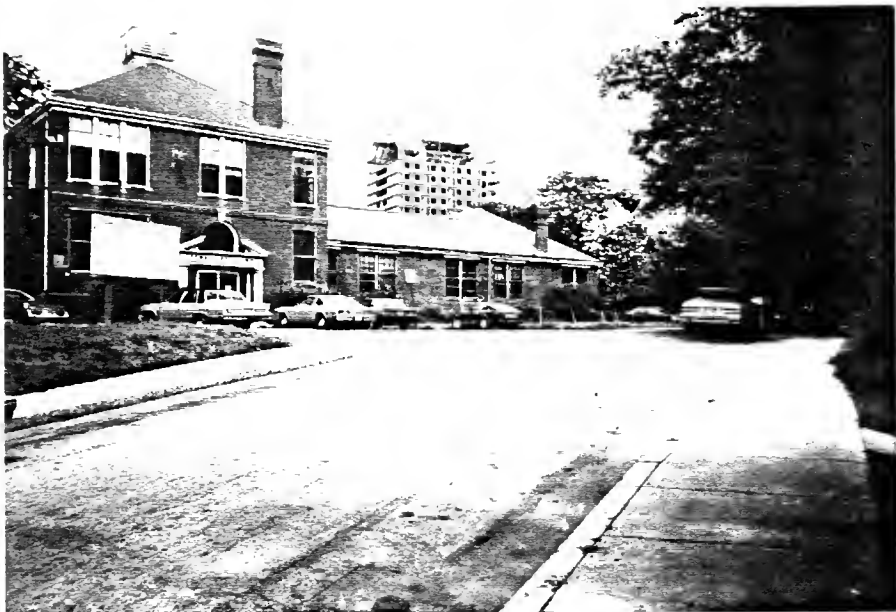
107

Central decision point
without focus or direc-
tional information.
Too much pavement. Too
many cars.

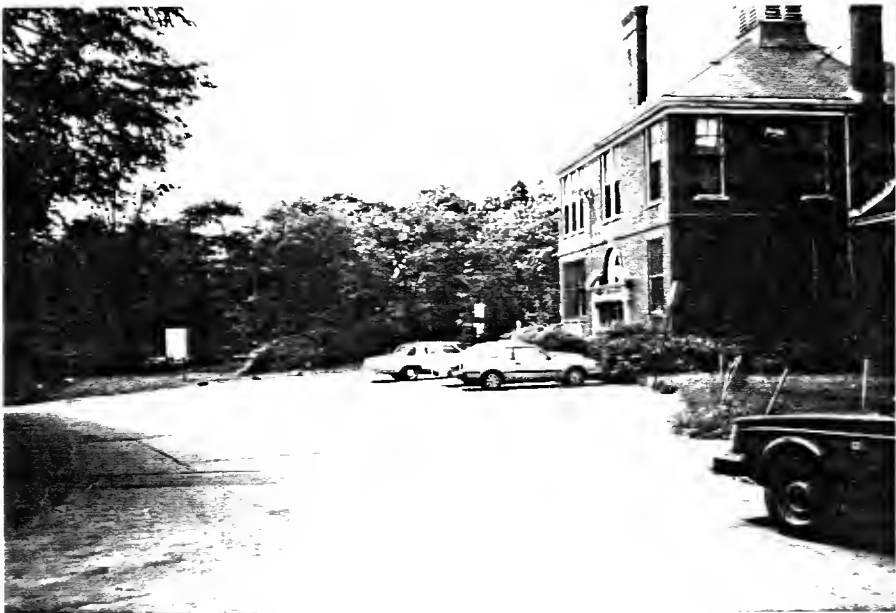
108

The curb cut on Dimock
Street is too broad.
The entrance to the
Sewall building needs
definition.

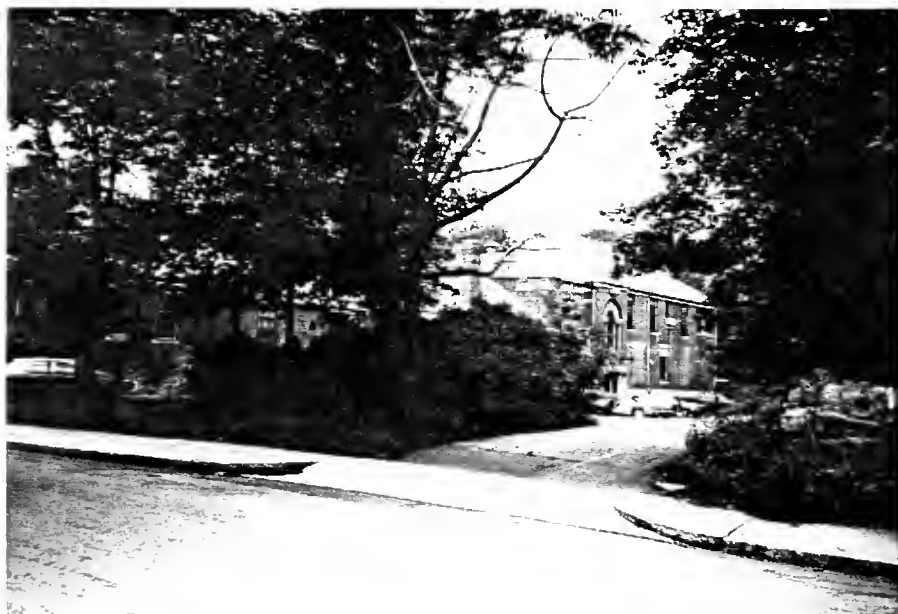
109

The entrance planting gives nice screening for the building but is seasonal. Evergreen materials should be planted and the dead limbs pruned.

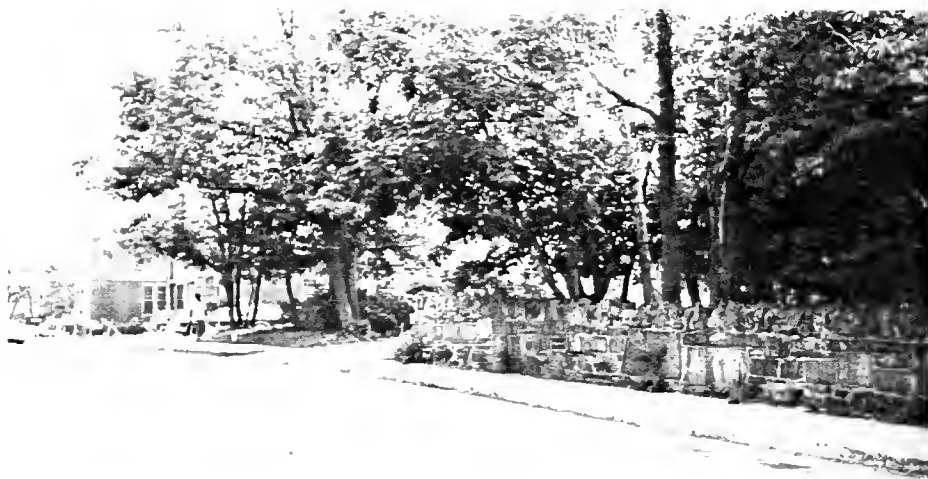
110

This is the entrance to the Dimock Center from Washington Street. There is no indication that one has arrived nor is directional information given.

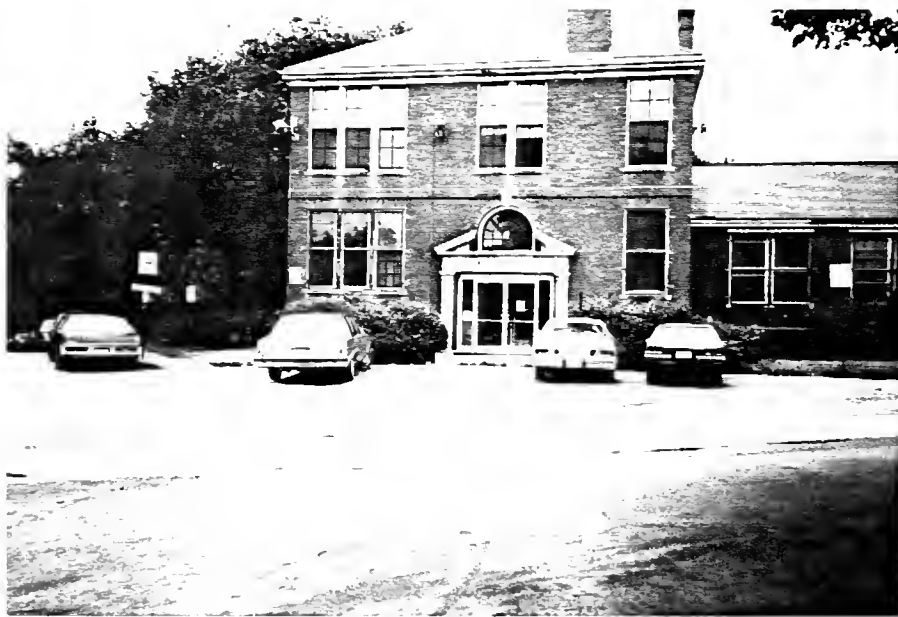
111

The entrance needs to be defined.
